Contract #: 04-0120F4Cty: SF/ALA Rte: 80 PM: 13.2/13.9File #: 1.28**WELDING INSPECTION REPORT****Resident Engineer:** Casey, William**Address:** 333 Burma Road**City:** Oakland, CA 94607**Report No:** WIR-028818**Date Inspected:** 05-Dec-2012**Project Name:** SAS Superstructure**OSM Arrival Time:** 700**Prime Contractor:** American Bridge/Fluor Enterprises, a JV**OSM Departure Time:** 1730**Contractor:** American Bridge/Fluor Enterprises, a JV**Location:** Job Site

Bridge No: 34-0006**Component:** SAS Tower**Summary of Items Observed:**

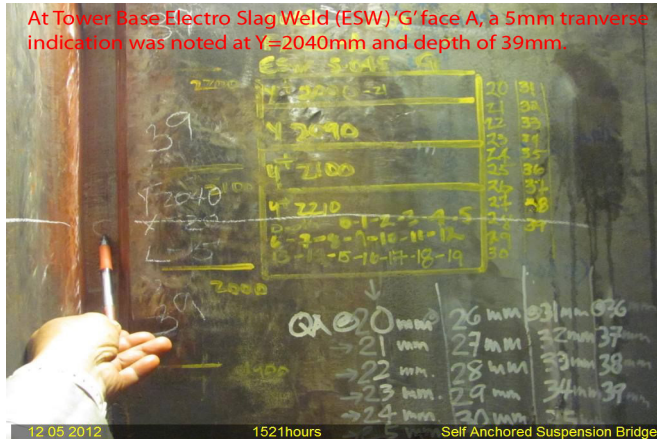
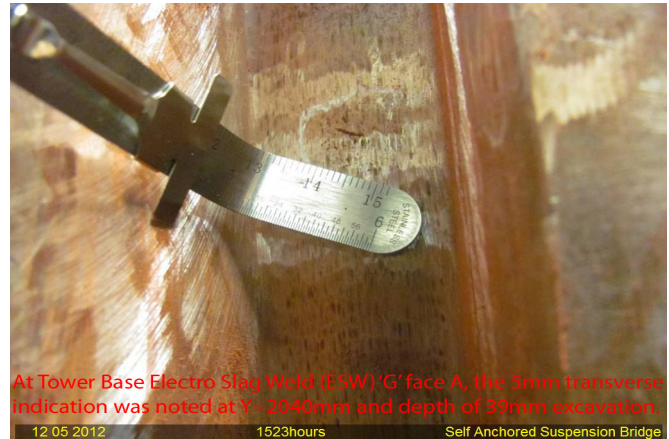
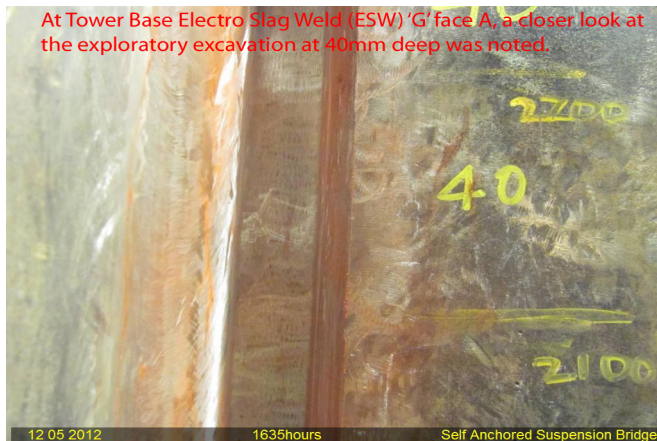
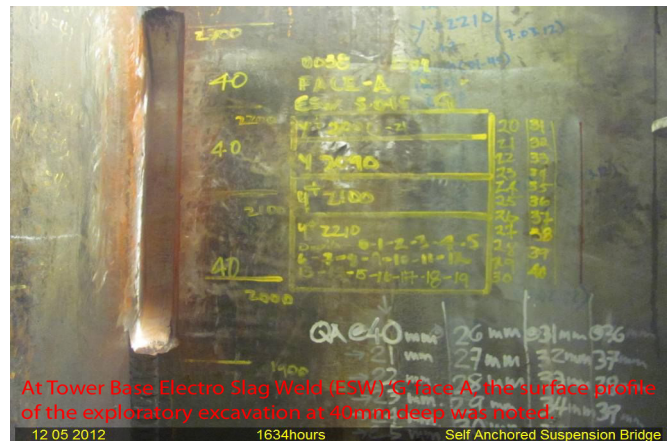
At Tower Base Electro Slag Weld (ESW) 'G' weld joint #S-045 face A, ABF personnel was observed continuing to perform exploratory excavation on welded ESW at locations Y=2000, Y=2090, Y=2100 and Y=2210mm due to UT detected defects. The ABF personnel have resumed the exploratory excavation from 33mm deep where they left off Tuesday. The personnel were noted using only the disc grinder in every 1mm increments of excavation. ABF QC Jesse Cayabyab was observed performing Magnetic Particle Testing (MT) on the following various depths with one transverse indication noted so far. This QA also performed the same test and noted same result. During the shift, the ABF personnel continued the excavation in 1mm increments using the same method of test and verification up to 40mm with one 5mm long transverse indication noted. The shift was completed up to this depth of excavation.

The starting depth of excavation on this date was a continuation from the previous shift. The results of the exploratory excavations are as follows;

1. 33mm in depth – no significant indication noted.
2. 34mm in depth – no significant indication noted.
3. 35mm in depth – no significant indication noted.
4. 36mm in depth – no significant indication noted.

5. 37mm in depth – no significant indication noted.
6. 38mm in depth – no significant indication noted.
7. 39mm in depth – 5mm transverse indication noted @ Y=2040, X=-20
8. 40mm in depth – no significant indication noted. Transverse indication removed.

The exploratory excavations at this location will be continued on the following shift.

According to ABF QC Jesse Cayabyab, ABF personnel including QC were instructed to excavate up to 45mm deep.
